# **Arboricultural Impact Assessment Report**

# **1 Frewin Place Scullin ACT**

Report Author	Steve Griffiths Level 5 Arborist
Mobile	0491 640 719
email	steve@treereports.com.au
Report Date	27 January 2023

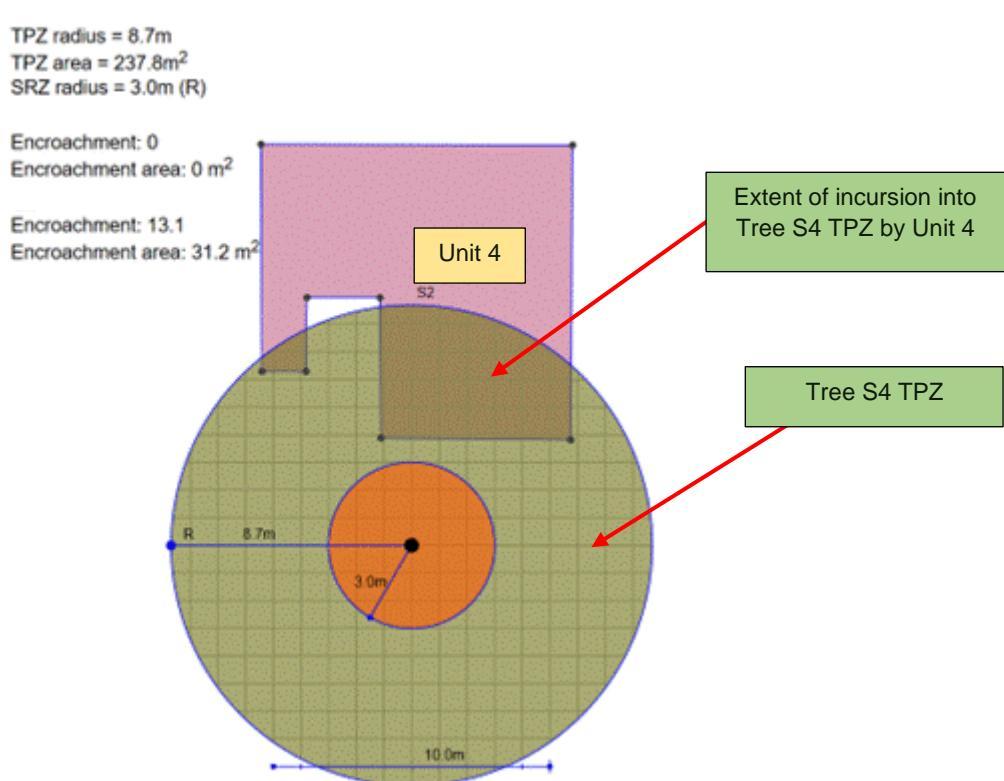
Figure 2. Tree S4 TPZ Incursion

The above illustration clearly shows there is an incursion of 31.2m<sup>2</sup>, which is 13.1% of the total root zone.

This appears to be an acceptable incursion if the new foundation has a minimal 50mm ground scrape and uses a waffle pod foundation. The placement of a temporary path between Unit 4 and Tree S4 is required to prevent compaction of the TPZ.

The placement of a permanent path beside Unit 4 must also be carried out with not more than 50mm of topsoil scraped away before placement of the base material for the path. Any compaction of the base must be light and carried out with a hand operated plate vibrator. No heavy rollers or vibrating roller are to be used in the tree's TPZ.

Under the building, any utilities going through the TPZ of this tree must be placed in the waffle pod rather than the ground - this includes all stormwater, sewer, electrical water, gas and communication cables. Placement of utilities within the TPZ must use hydro vacuum or under boring methods rather than open trenching.

Excavation for the proposed fence posts must use hydro vacuum within the Structural Root Zone (SRZ). Beyond the SRZ and within the TPZ hydro vacuum or Mega anchor system must be used when excavating holes for the fence posts.

An irrigation system is to be provided to this tree's entire TPZ and operated during drought or summer to maintain adequate soil moisture for the duration of works.

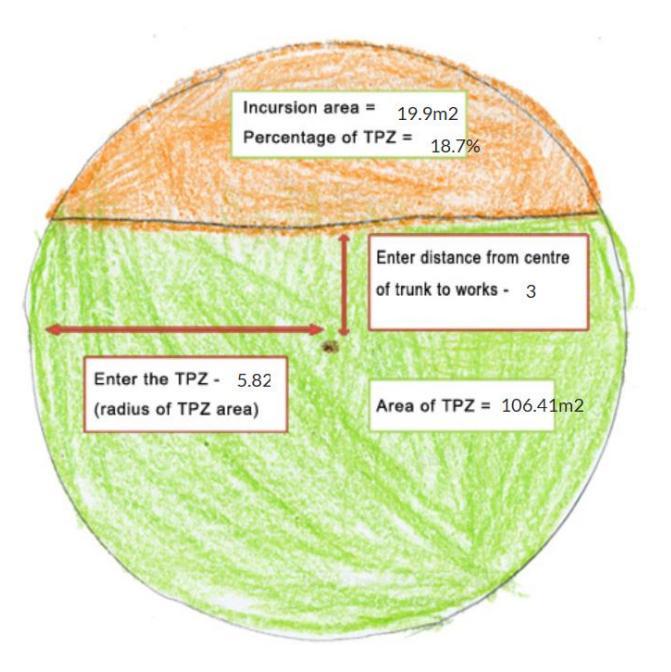
Figure 3. Tree S9 TPZ Incursion

The figure above shows the extent of incursion of Unit 1 into the TPZ of Tree S9. This shows the TPZ to be 5.82 metres in diameter with Tree S9 located three metres from the building.

This is a significant incursion (18.7%) into the tree's TPZ. It may be possible to retain the tree by using a waffle pod construction method for the footings. The installation of services to the building through the TPZ would require hydro vacuum or under boring methods to be used to minimise the impact of works on the tree.

If this approach is not acceptable this tree can be removed because it does not, at present, meet the size that requires it to be protected under ACT legislation.

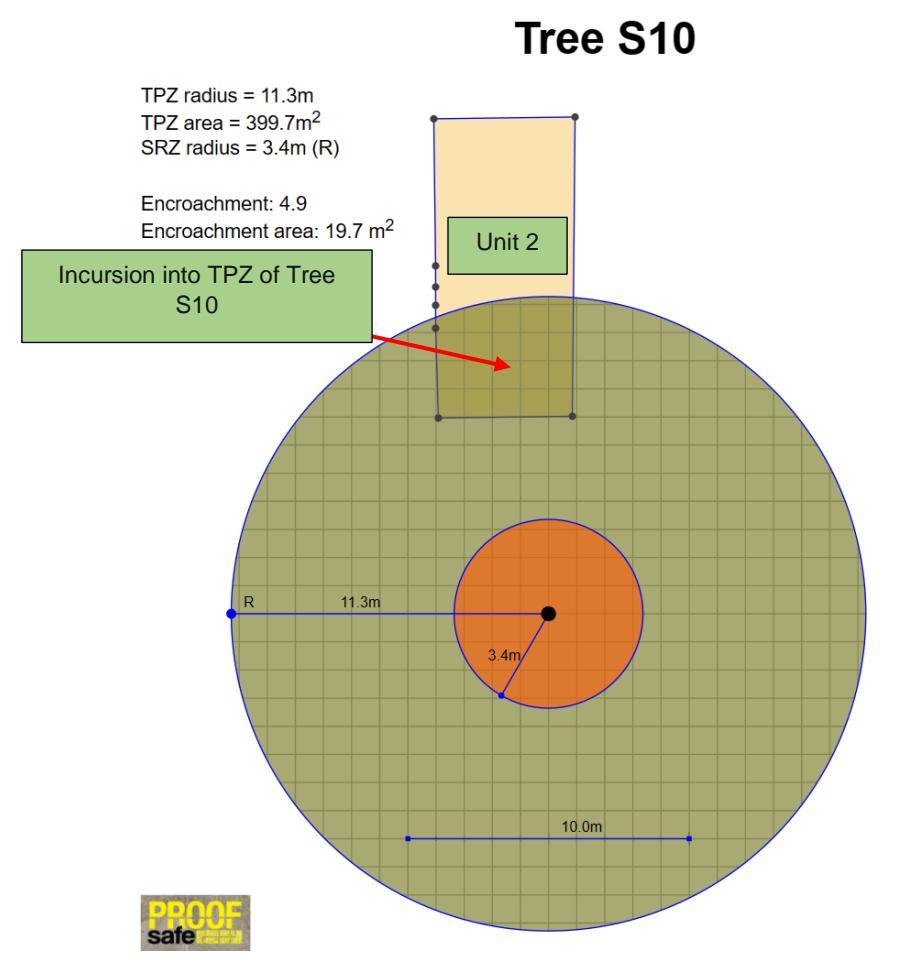
Figure 4. Tree S10 TPZ Incursion

The above illustration clearly shows there is an incursion of 19.7m<sup>2</sup>, which is 4.9% of the total root zone. This appears to be an acceptable incursion if the new foundation has a minimal 50mm ground scrape and uses a waffle pod foundation above the TPZ. The placement of a temporary path between Unit 2 and the tree is required to prevent compaction of the TPZ. The *Proposed Site Plan* on page 11 shows the location of the required temporary path and TPF for this tree.

The placement of a permanent path beside Unit 2 that extends into the TPZ must also be carried out with not more than 50mm of topsoil scraped away before placement of the base material for the path. Any compaction of the base must be light and carried out with a hand operated plate vibrator. No heavy rollers or vibrating roller are to be used in the tree's TPZ.

Under the building, any utilities going through the TPZ of this tree must be placed in the waffle pod rather than the ground - this includes all stormwater, sewer, electrical water, gas and communication cables. Placement of utilities within the TPZ must use hydro vacuum or under boring methods rather than open trenching.

Excavation for the proposed fence posts must use hydro vacuum within the SRZ. Beyond the SRZ and within the TPZ, hydro vacuum or Mega anchor system must be used when excavating holes for the fence posts.

An irrigation system is to be provided to this tree's entire TPZ and operated during drought or summer to maintain adequate soil moisture for the duration of works.

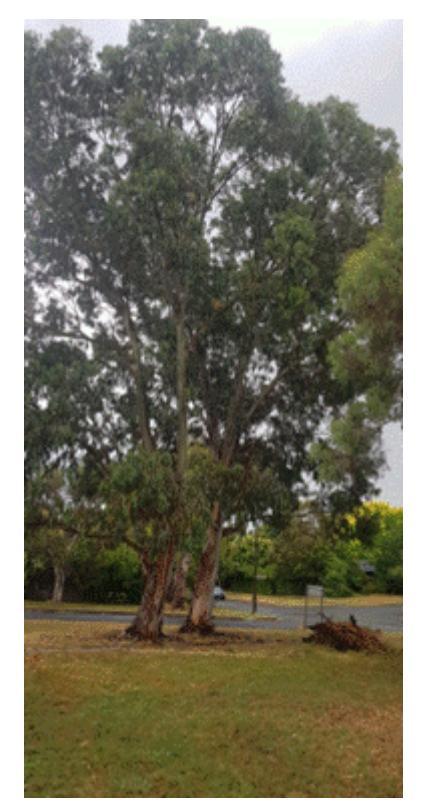
Figure 8. Left to right - Trees S4 and S5. Protective measures required

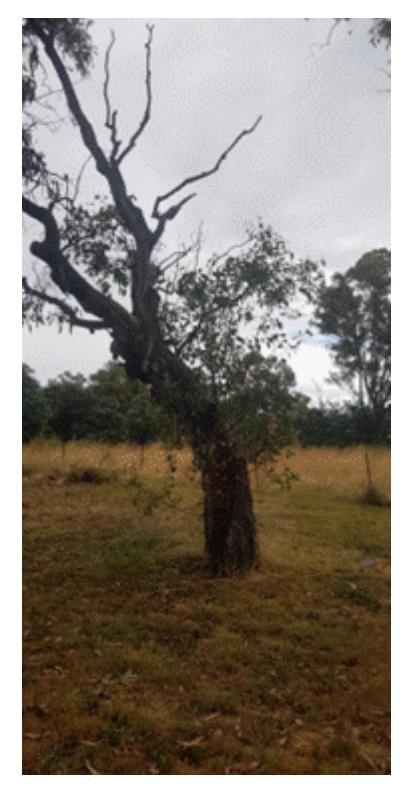
Figure 9. Tree S6 – In decline and in poor condition. Removal recommended

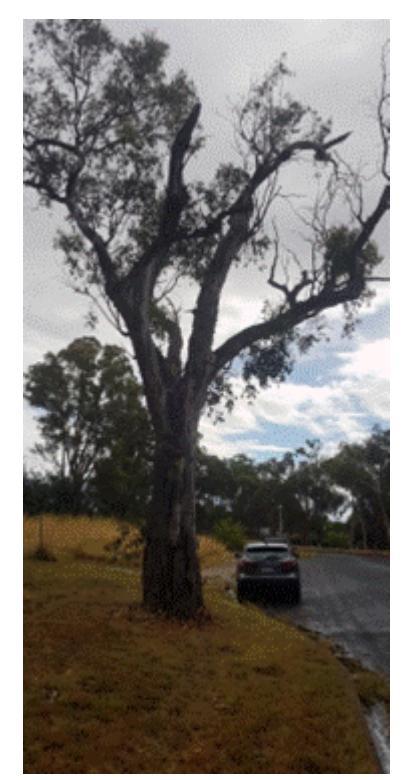
Figure 10. Tree C7 – large hollow over road and in poor condition. Removal recommended

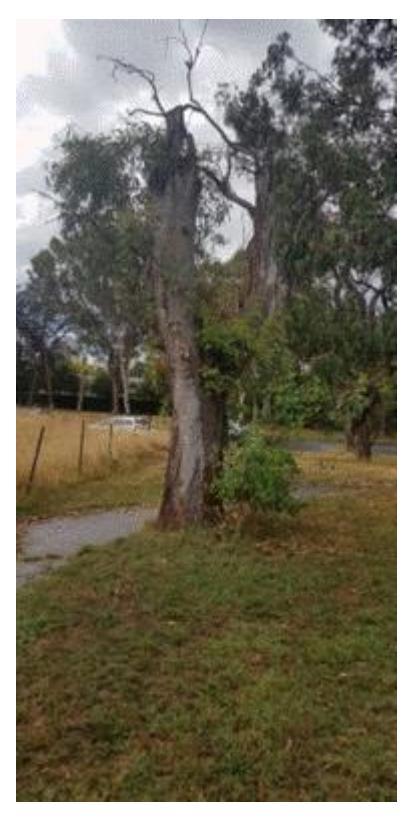
Figure 11. Tree S8 – In poor condition. Removal recommended

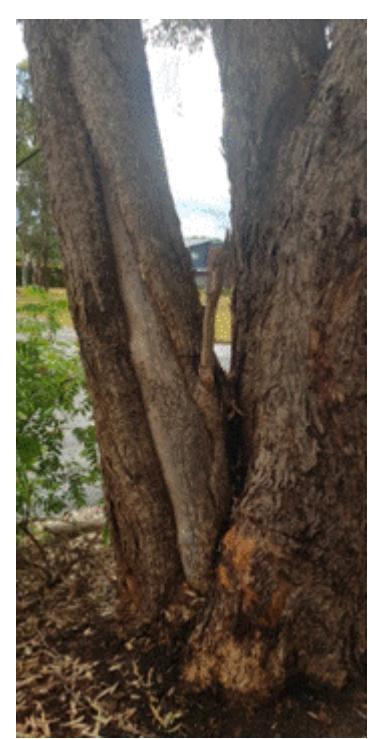
Figure 14. Tree S10 showing scar healing and trunk union with included bark. Inspect every 12 months

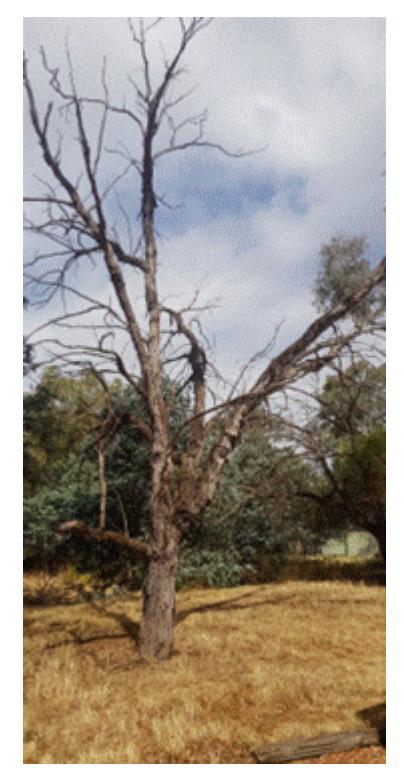
Figure 15. Tree S11 – removal recommended
